CRG Research Report

The First-Generation Camaro Assembly Process

© 2003-2018, Camaro Research Group

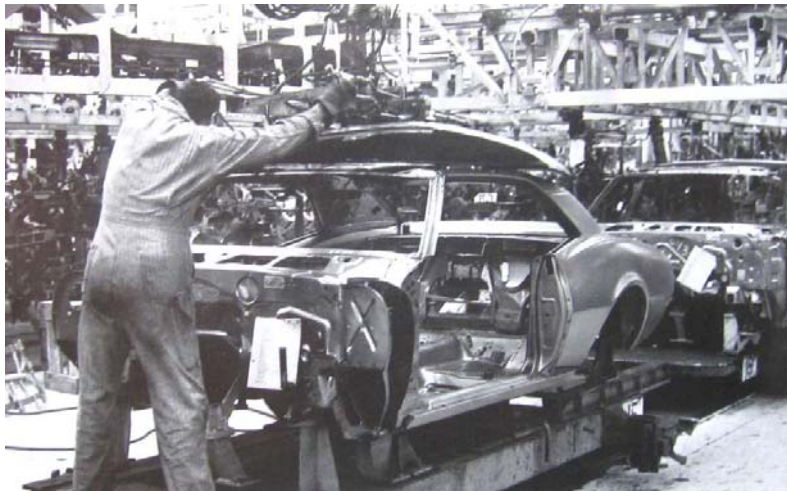
Body Framing - Roof Skin Installation

Body Framing: As the body build truck entered the framing line carrying the completed underbody, the side frame fixtures shuttled in from each side and were locked in place against locators on the build truck; two pairs of diagonal crossbars were added to tie the side frame fixtures together at the top, the upper windshield and backlite headers were loaded, and hundreds of spotwelds were made to tie the side frame assemblies to the underbody. After the headers were welded, the crossbars were removed, the cowl tag was installed, and the roof skin, tulip panel (the panel between the backlite and the deck lid opening), and rear end panel were loaded and welded. At the end of the framing line, the body was lifted and transferred to a simpler, lighter carrying truck, and the precision body build truck returned on its loop conveyor back to the underbody line.

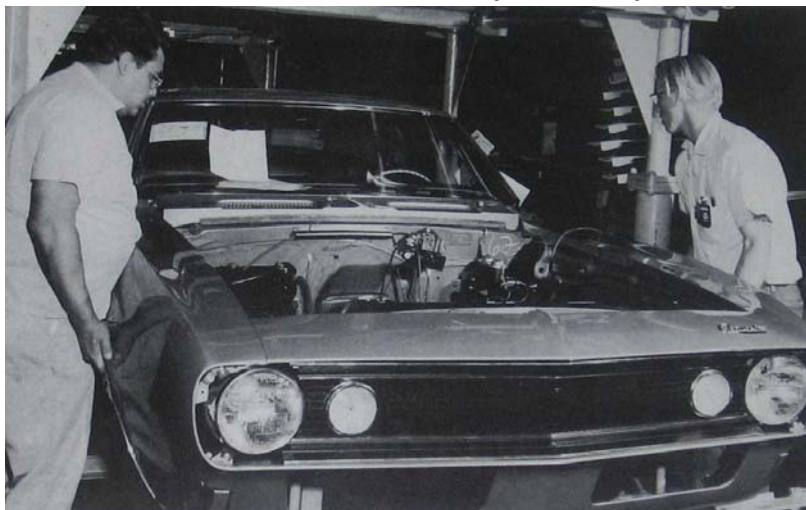
Front Sheet Metal Assembly at Van Nuys

The "buck-built" front clip was lowered into place with an overhead hoist; two operators guided it into position, pulling the rear of the fenders outboard to clear the side shroud "saddlebags" on the body as the assembly moved rearward. The hook was then released and the hoist went back upstairs to pick up the next assembly. At this point, operator skill became critical as the shim packs were made up and stuffed in place for the top, front, side, and bottom fender-to-body attachments to achieve the correct gap and flush fits between the fenders and the body.

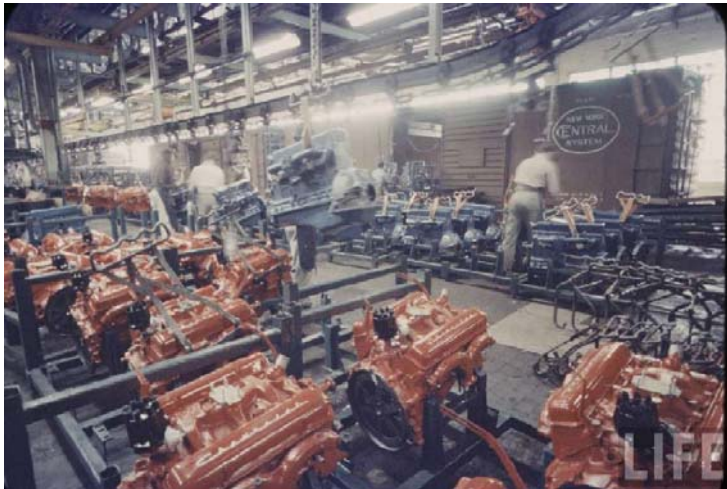
Engines As Received (at Tarrytown Assembly Plant, 1959)

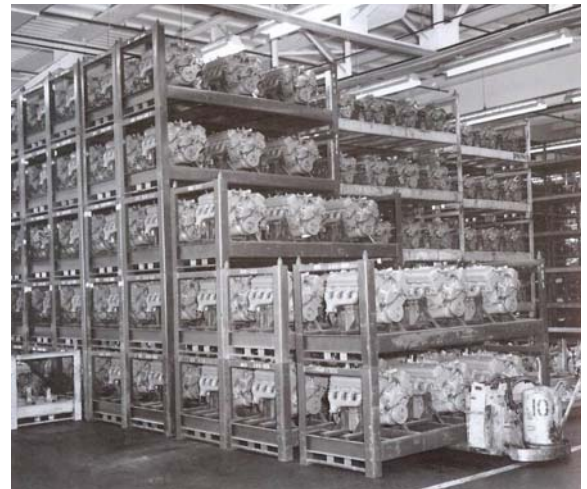
Racks of Big Block Engines

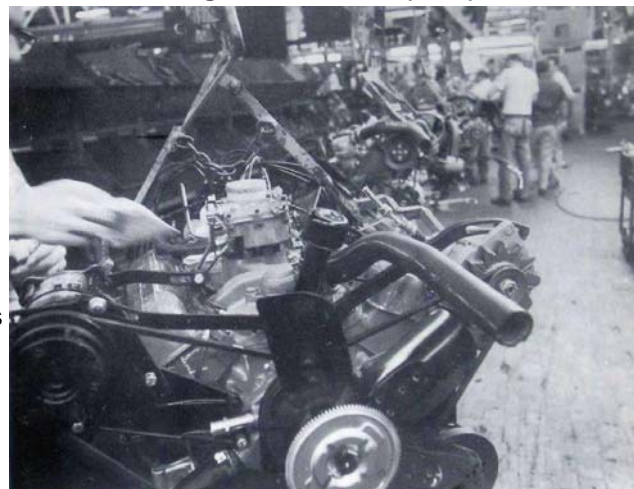
Engine Dress Line (1967)

The VIN derivative numbers were stamped in the next operation on both the engine pad and the transmission, using a gang-stamp holder and a hammer. From here on, all the detail dress items were added (plug wires, coil, engine harness, battery cables, carburetor, pulleys, alternator, starter, fan and clutch, A/C compressor, power steering pump, transmission cooler lines and fill tube, A.I.R. pump,

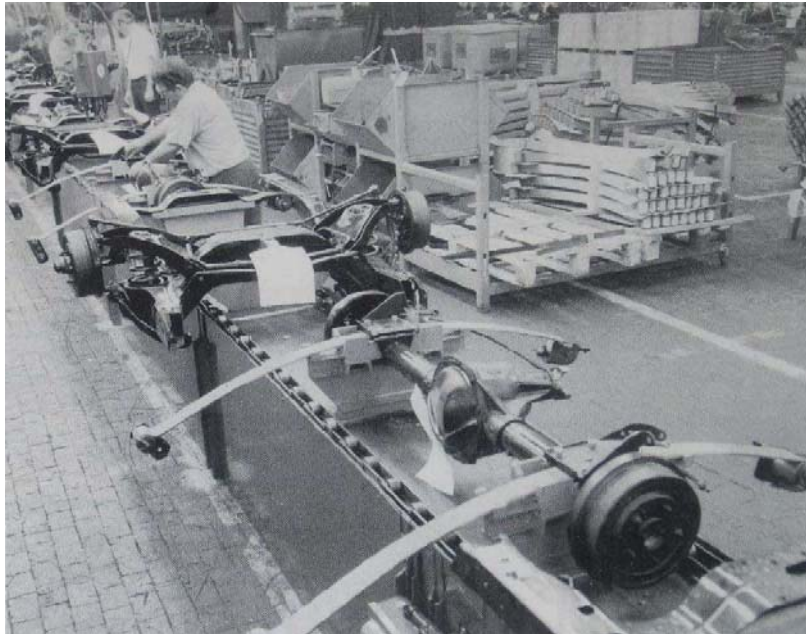
Chassis Assembly Line

The subframe was built up separately on a feeder line; the bare subframe was loaded on a conveyor, where the frame-side engine mount brackets were installed. Next, the upper and lower control arms and stabilizer bar were loose-installed, followed by the front springs and hub/spindle/brake caliper assemblies. It was then loaded into the "Geo-Machine", which set caster and camber. The machine clamped the subframe down solid against locators, and a swiveling head on each side was bolted to the front hub lug studs; when the machine was cycled, the machine heads compressed the hubs to design suspension height and positioned the wheel mounting face of the hubs to the correct caster and camber angles, which created gaps between the upper control arm shafts and the bracket on the subframe. The operators stuffed both gaps on each side with shims positioned over the studs, and torqued the nuts on both sides and the bushing bolts through the lower control arm bushings, plus the stabilizer bar bushing and end link bolts; the machine then lowered the suspension to full rebound against the upper control arm bumper, the nuts were removed holding the machine heads to the hub faces, and the subframe was transferred out of the machine, flipped upside-down, and the steering gear, pitman arm, idler arm, and steering linkage were installed. The subframe was then flipped right-side-up and loaded on the chassis carrier truck.

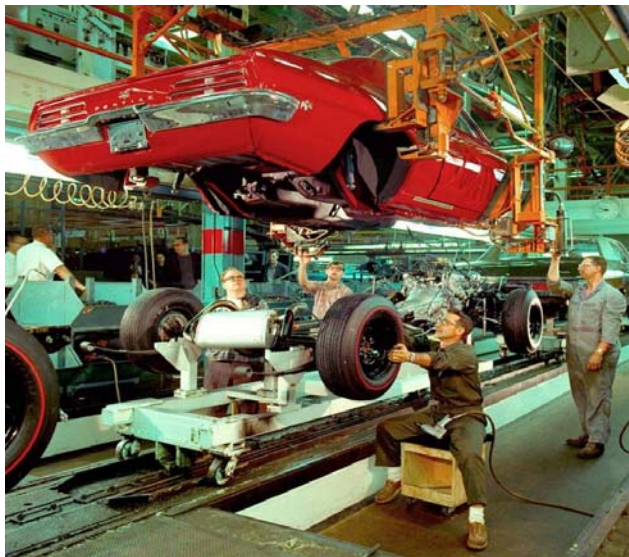
Body Drop Tackle and Chassis Pedestal Conveyor

The Body Drop operation in any assembly plant was always exciting to see, and Norwood was no exception. The overhead "clamshell" body drop tackle device picked the body up off its trim truck and transferred it to a position directly over the Chassis Line pedestal conveyor; the operators in the side pits installed the body drop gage pins in the #2 subframe mounts, and guided the body the rest of the way down onto the subframe and the rear springs. The #2 and #3 body mount bolts were driven, the rear spring front mounts and rear shackles were secured, and the overhead tackle returned to the end of the Trim Line to pick up the next body; the body and chassis continued down the Final Line for front sheet metal installation. Photo below shows the Firebird body drop at Lordstown - the Norwood Camaro body drop process was identical.

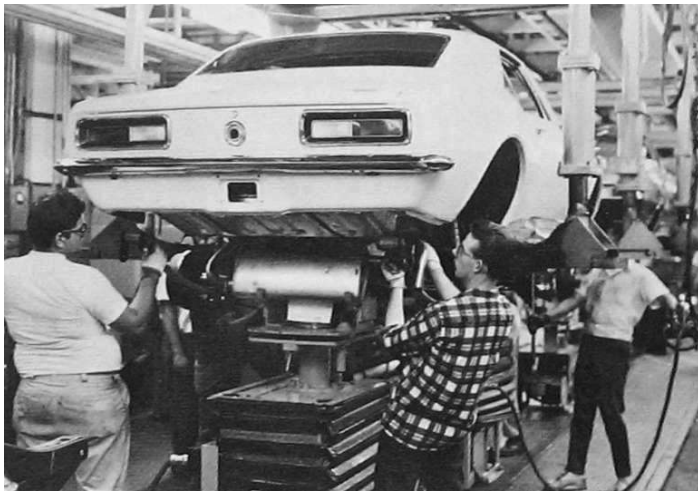
Chassis Being Raised into the Body

Although dramatic to watch, the chassis-to-body marriage at Van Nuys was a pretty straightforward operation. At Van Nuys, the traditional "body drop" process was actually a "chassis raise" process, where the complete chassis was raised up into an elevated body shell. It began with the chassis mounted on a waist-height Towveyor chassis carrier, that was in turn on a pedestal floor conveyor. The body (with the front sheet metal already installed) was suspended in an overhead conveyor carrier about six feet off the floor directly above the chassis carrier. The 0.610-inch diameter gage pins were snapped into place on the No. 2 subframe mounts, and the chassis was raised up to the body by hydraulic cylinders on the Towveyor. The four subframe-to-body and two subframe-to-radiator support bolts were torqued, the gage pins were removed, the rear springs were secured to the body at both ends, the rear shocks were attached at the spring plates, the exhaust hangers and brake & fuel lines were partially attached, and the Towveyor dropped back to waist height and returned around its loop to pick up another chassis. The "married" body and chassis continued on down the line suspended in the overhead carrier, six feet off the floor, to finish buttoning-up the underbody, lowered to waist height for wheel & tire installation, and the car was then deposited on its wheels on the dual-strand flat-top Final Line conveyor as the empty overhead conveyor carrier went up an incline and returned to the end of the Trim Line to pick up another body.

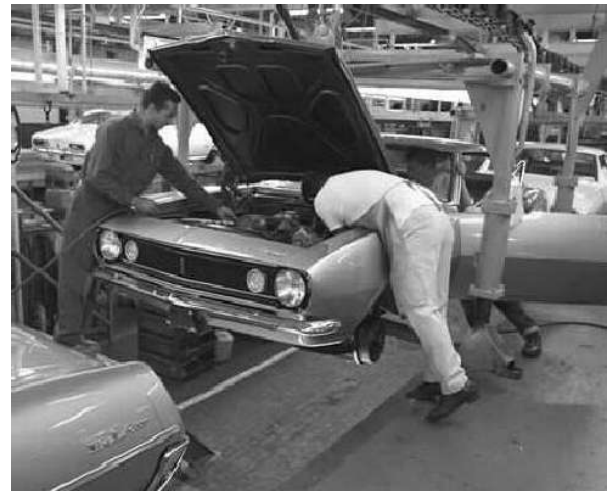
**On the Final Line**

Subsequent operations in the Final Line center pit were the same in both plants: the speedo cable was connected, fuel and brake line clips were secured to the underbody, the rest of the exhaust hangers were attached, the main fuel line was attached to the hose from the fuel tank, and the parking brake cables were secured and adjusted. Automatic shift linkage and clutch linkages were adjusted, the backdrive linkage was connected and adjusted, and the convertible floorpan brace was installed.

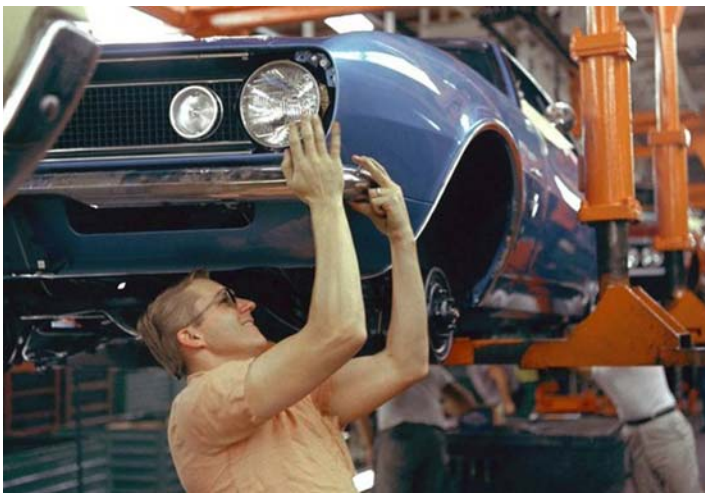
Other Operations

The front bumper was installed, radiator and heater hoses and transmission cooler lines were connected, the battery was installed, A/C hoses were connected, and the fan shroud was installed, while the jack and spare tire were secured and wheel covers and floor mats were placed in the trunk. The washer bottle was installed and the washer nozzles were aimed, and both the cooling system and A/C system were evacuated and filled automatically, followed by a pair of operators aiming the headlights; pinstriping fixtures were applied and Z21/D96 pinstripes were painted with Buegler roller-stripping guns, and D90 door stripe decals were applied.

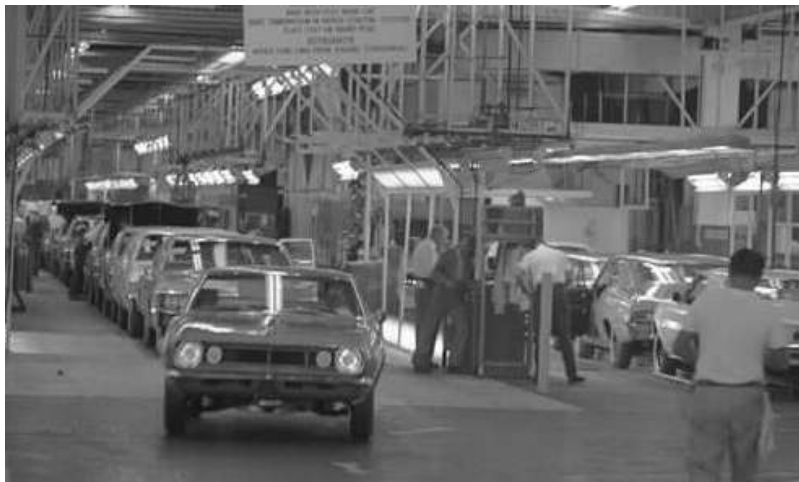
Final Line Drive-Off - Completed and Driving
